TALQUIN
Electric Cooperative

ENERGY USAGE ANALYSIS

Located at;
123 Any Street
Tallahassee, Florida
32311

ENERGY SERVICES
DAN L. ARD
MARCH 4, 2009

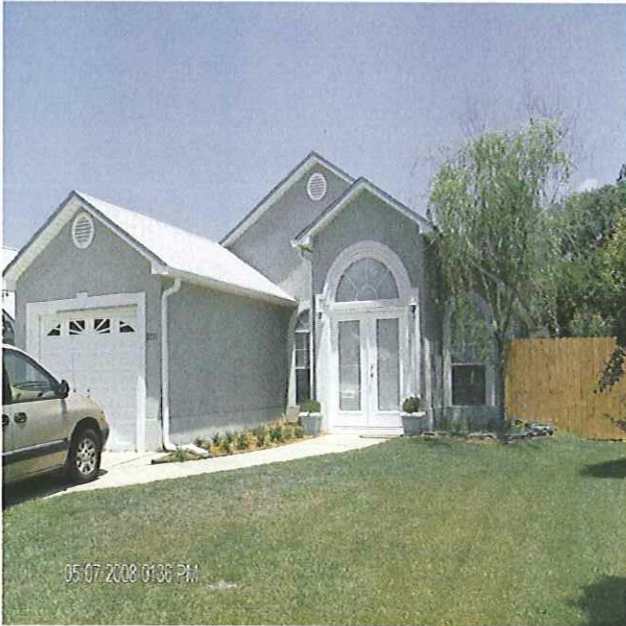
- This is the Southwest facing of the home. Light colors are an appropriate choice for this climate zone.

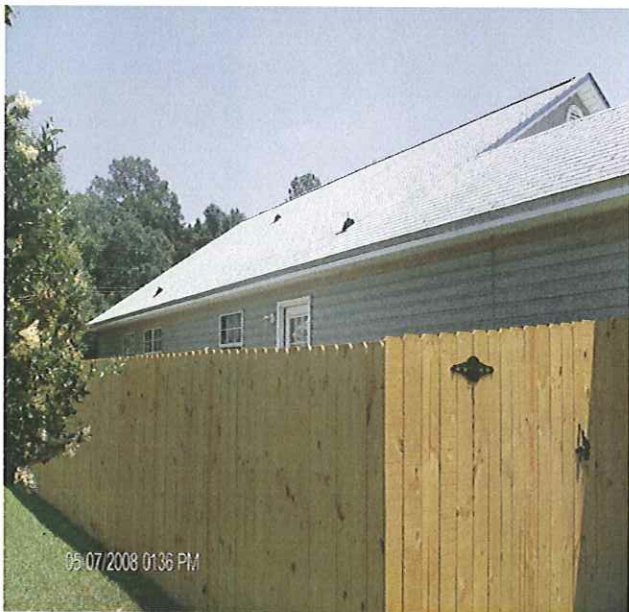
- A limited amount of green space shading exists to reduce thermal gain.

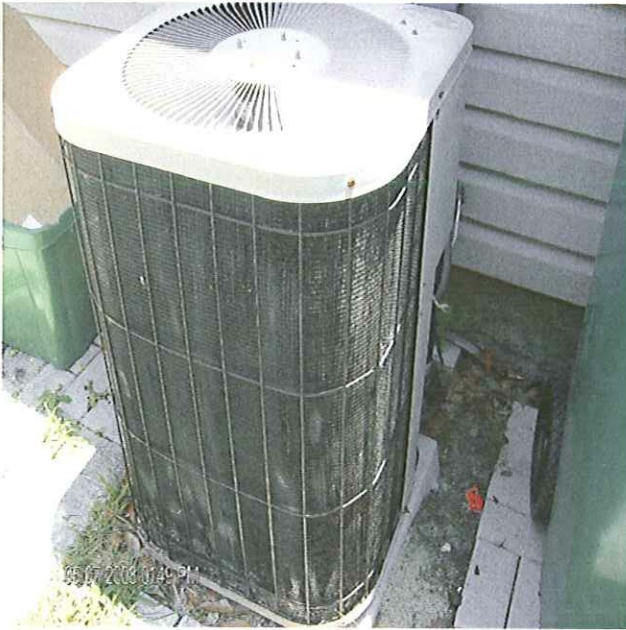
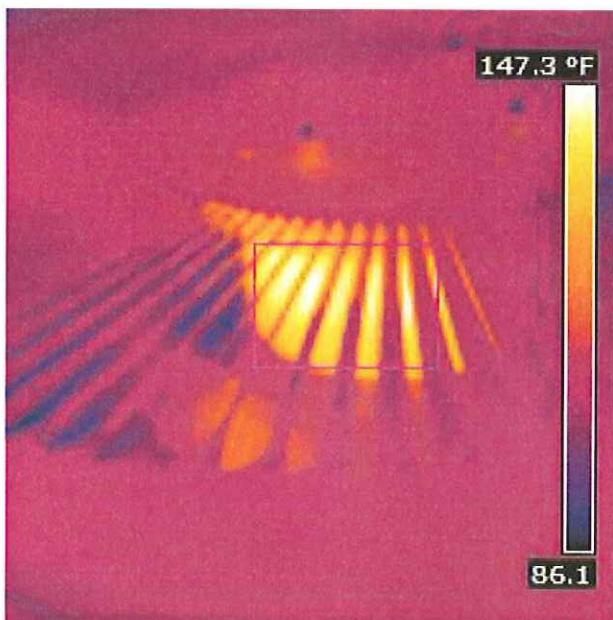
- These images are of the compressor component of the HVAC system.

- Some heat retention exists in the fan motor, which should be further inspected to determine possible efficiency reduction.

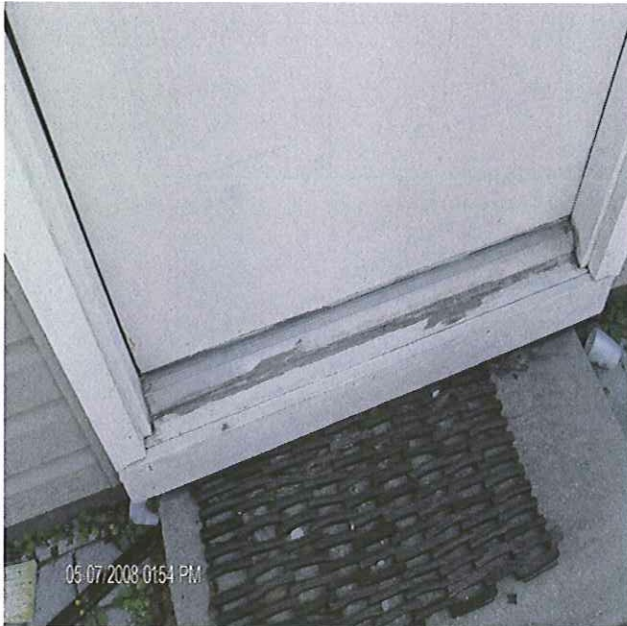
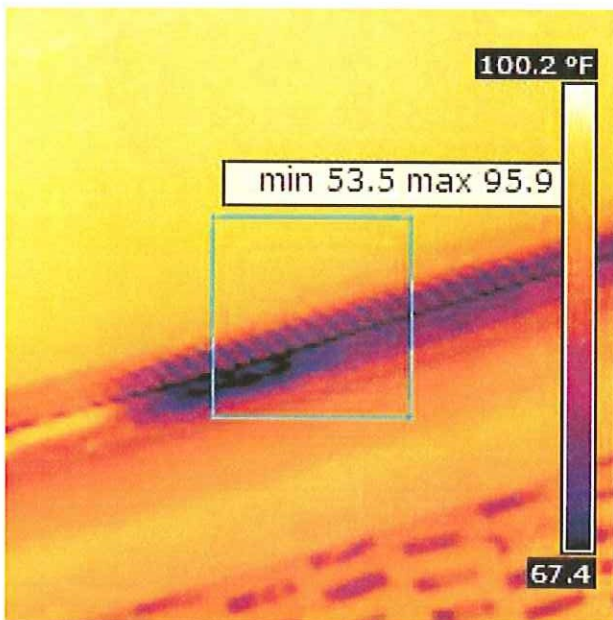
- This is an image of the front entrance door.

- The IR image reveals the conditioned air loss past the inadequate door seal. The following page shows additional images of either conditioned air loss or outside air infiltration issues.

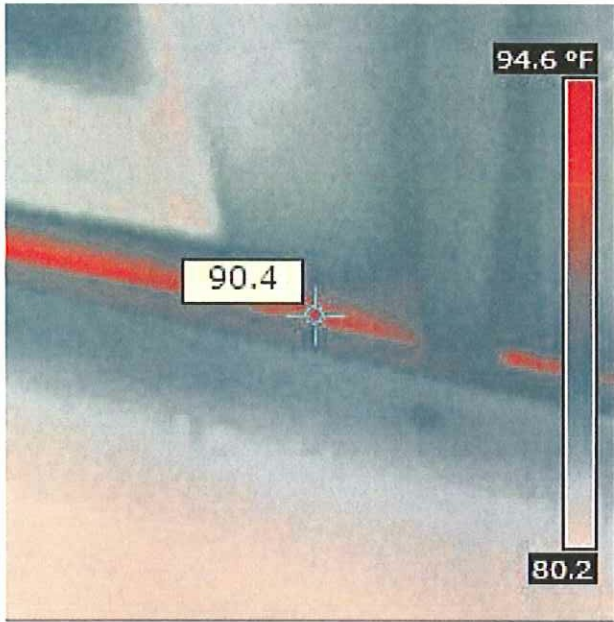
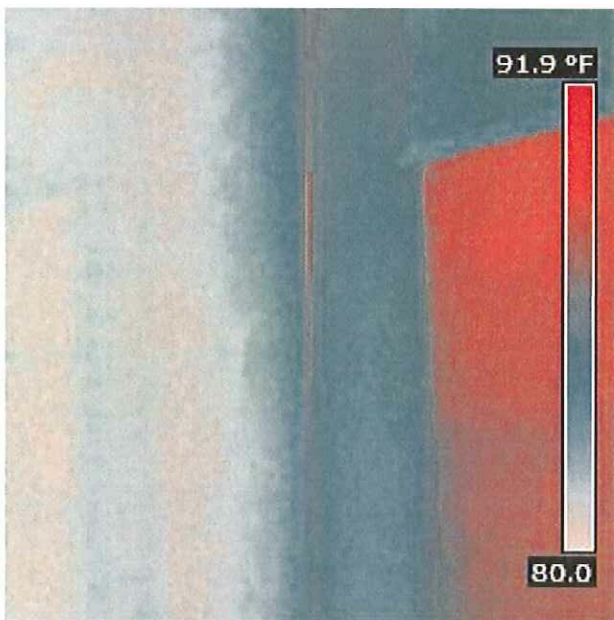
- These are images of heat transfer into the conditioned space. This condition will greatly influence the ability of the HVAC system to cool the home.

- This condition can be corrected by replacing inadequate weather-stripping and installing a solar radiant barrier film on all the windows.

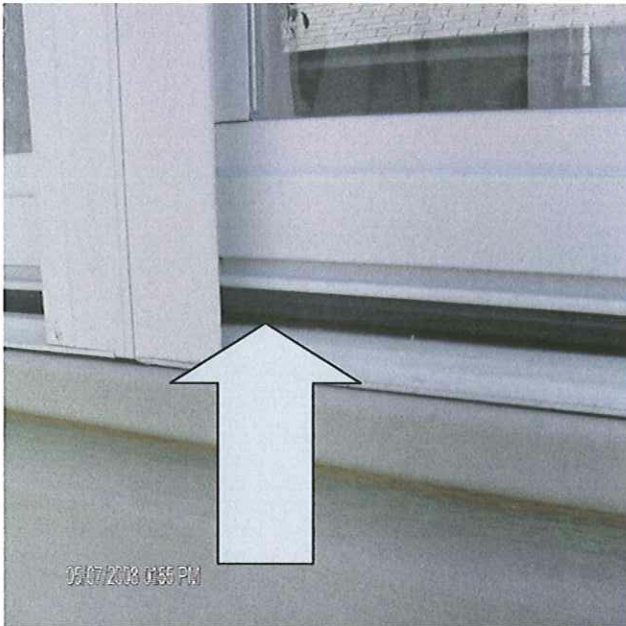
- Although not clearly visible, this window does not completely seal as it should. This will allow outside air into the structure.

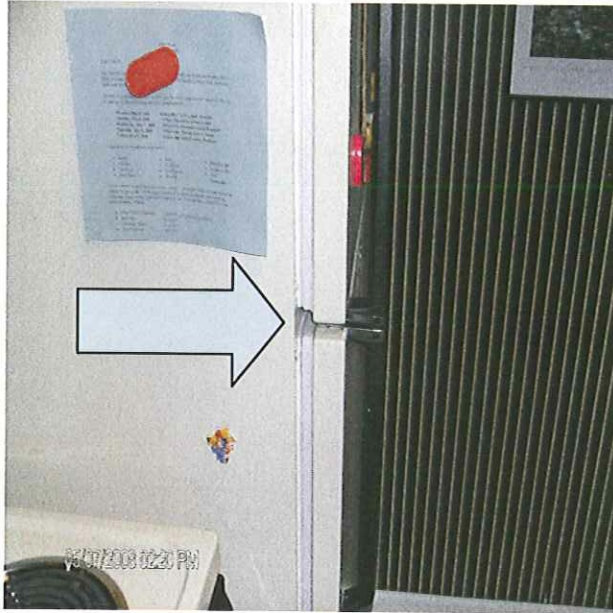
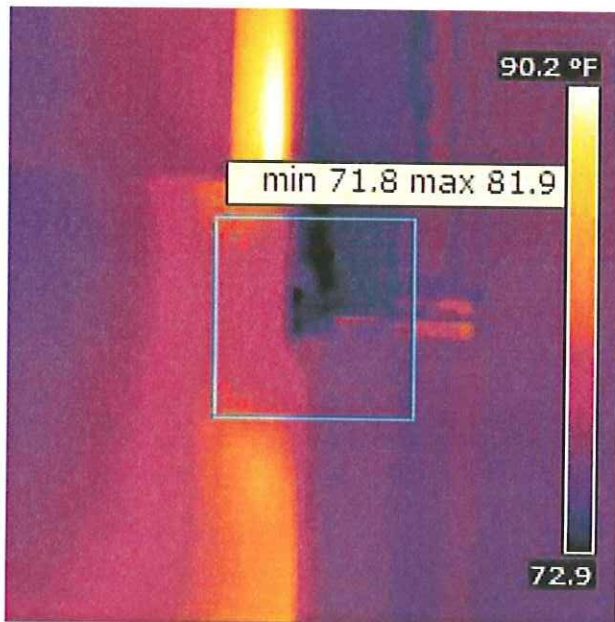
- These images reveal the cold air loss past the gasket seal. This condition will severely reduce the efficiency of the unit. This may be corrected by cleaning the gasket seal and door facing to remove any debris. If this does not correct the problem a qualified service technician should be contacted to repair or replace the gasket.

1. I recommend that the refrigerator gasket be repaired as discussed on page 9 of this document.
2. I suggest that a solar radiant barrier film be installed on the windows to reduce the amount of heat gain now experienced. Sample film used at the time of analysis, reduced heat gain from 86 Btu's per hour to 14 Btu's per hour.
3. The building envelope should be more tightly sealed to reduce the conditioned air losses. This will require replacement of the weather-stripping around the exterior doors.
4. Insulation should be installed on the exposed water lines to increase the efficiency of the water heater.
5. I recommend that a power attic exhaust fan be installed to reduce the extreme heat gain now effecting the ability of the HVAC to cool the residence.

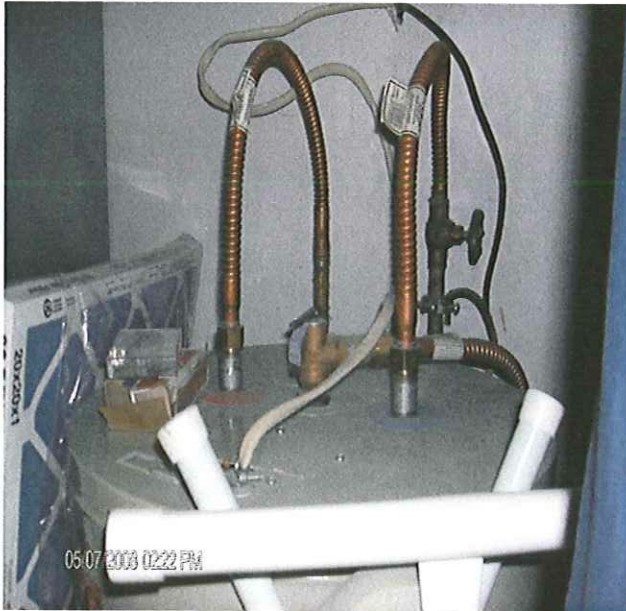
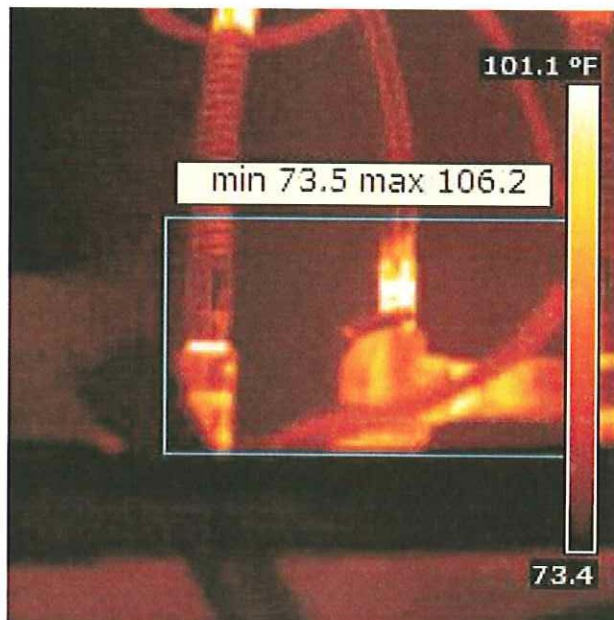
- The photograph to the left shows the lack of insulation on the exposed water lines.

- The Thermal Image reveals the result of the uninsulated water lines. This condition reduces the efficiency of the system.

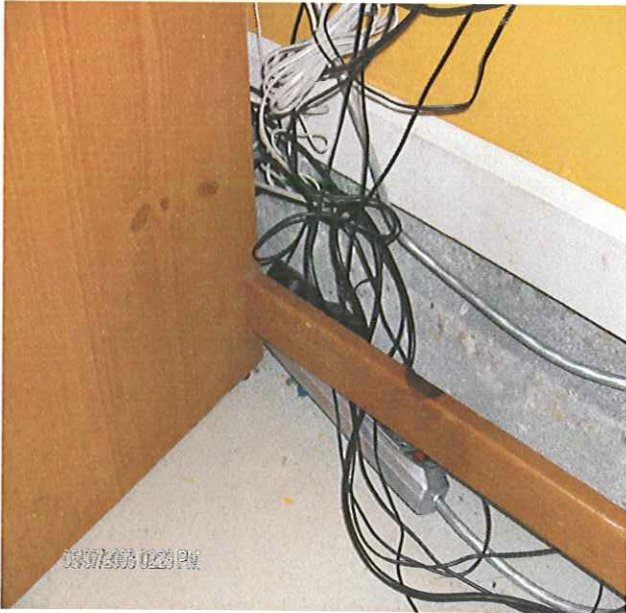
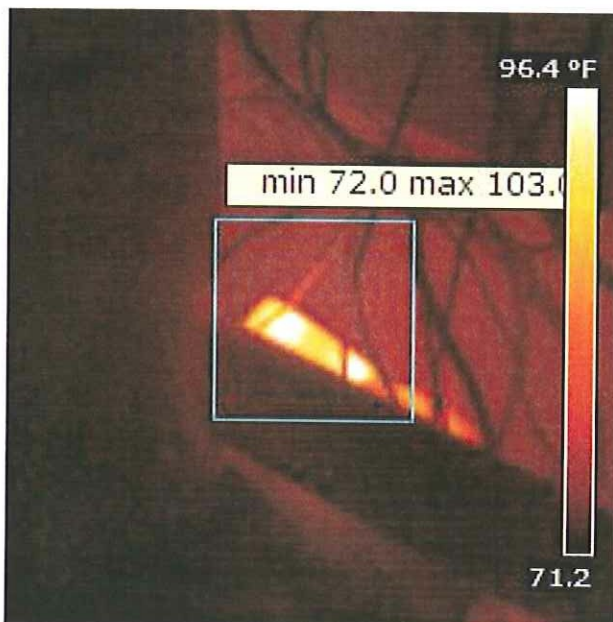
- All electronic components continue to draw power even when not actively used. This condition is commonly known as “vampire power”. The power strip seen here can be turned off at the switch, which will correct the energy loss. This is only one of the locations seen within the home that contribute to the overall energy consumption.

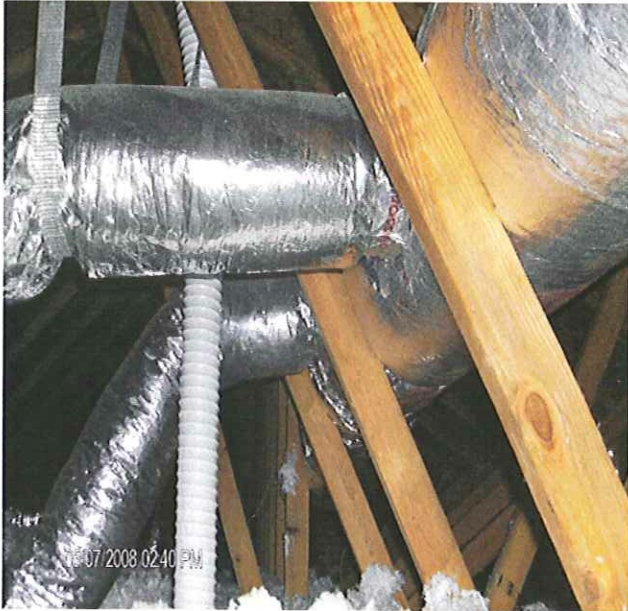
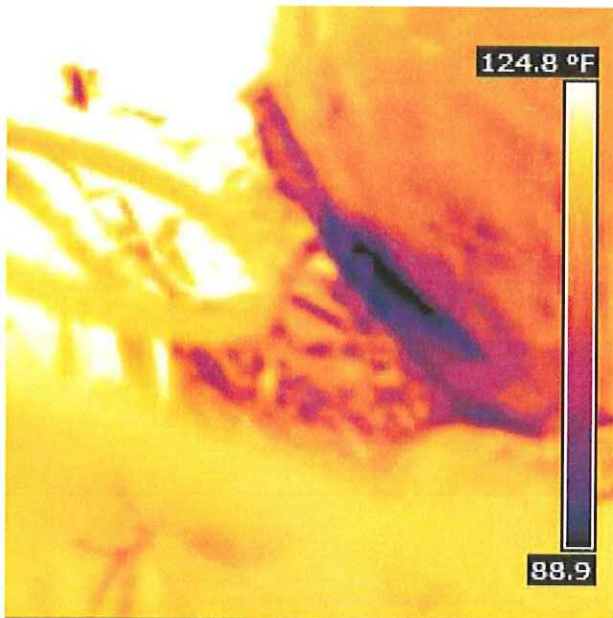
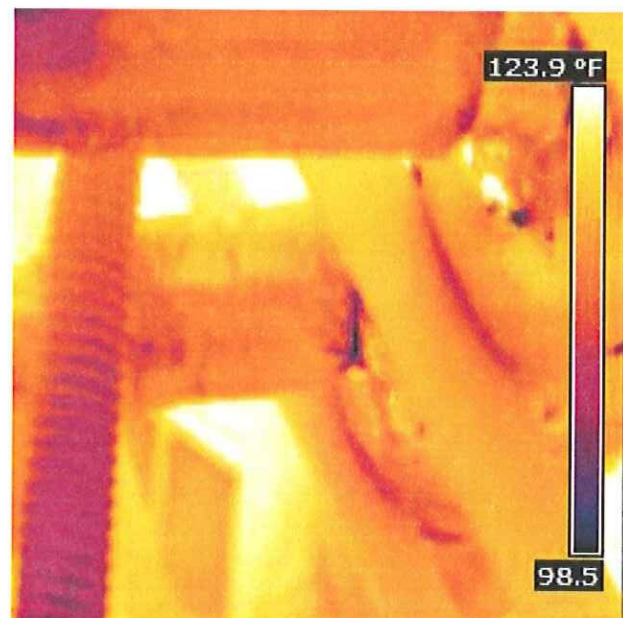
- These photos show the cold air loss with the A/C in use. The dark blue areas show the air loss. These connections should be sealed to increase the efficiency of the system.

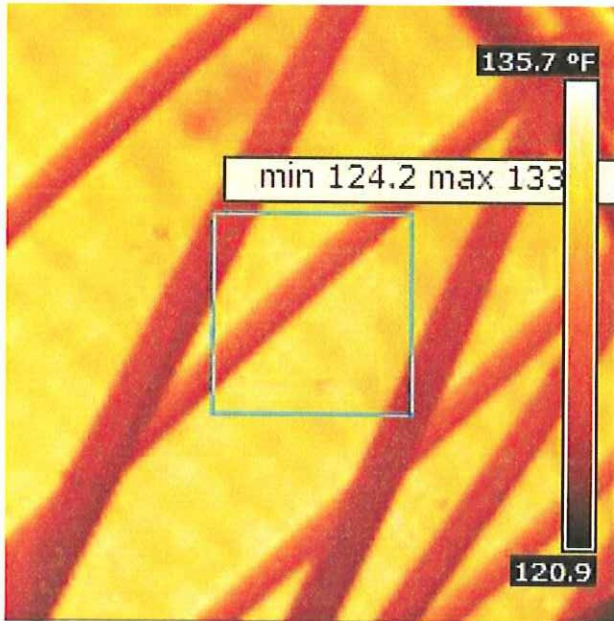
- This IR image reveals the extreme heat gain within the attic space. This condition will effect the ability of the HVAC to effectively or efficiently cool the home.
